## Safety Alert to Haulier's

Z Energy had an incident this week in one of our gantries where the emergency vents closed/lifted on a haulier's trailer while loading. This could have resulted in a compartment rupture.

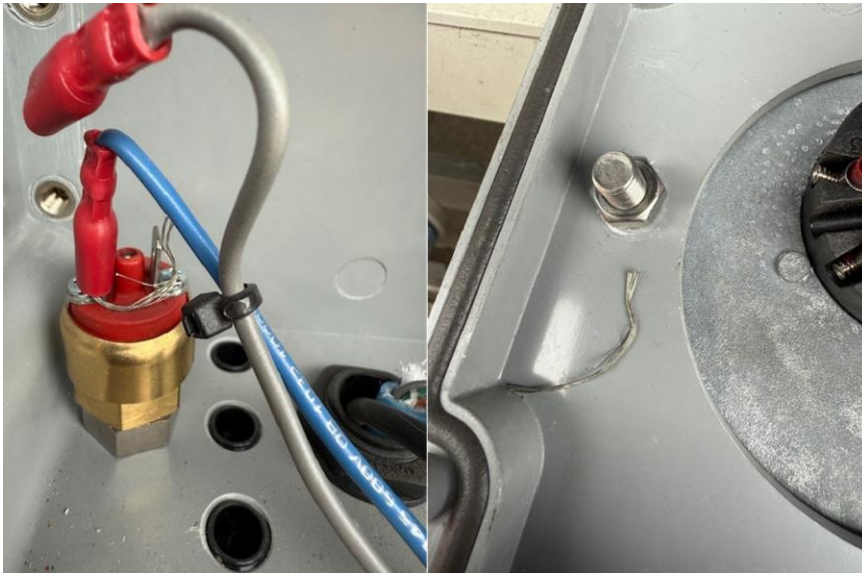
- Drop in air pressure during the loading process causing vents to close on the trailer.
- The pressure switch on the air system is designed to stop loading if pressure falls below 4 bar and is linked to the overfill protection system (Scully), which had been bridged out (see photo below). It appears this has been installed to diagnose a pressure system fault and had not been removed before the trailer was returned to service.

*The gray wire has been removed from the terminal for the purposes of taking the photos. But was in place when the bridging wire on the pressure switch was discovered.*

On further investigation another trailer that had been returned from the same workshop has also been found with the pressure switch bridged out.

This is a high potential incident when loading at full flow with closed venting. The pressure in the compartment could cause a failure of the tank barrel and possible loss of containment. This could result in personal injury to driver and/or potential fire in the loading gantry through high pressure release of fuel and ignition through static charge generated by the fuel jetting through ruptured barrel.

**Request** for haulier's to have their fleet checked and confirm there have been no other instances of the pressure switch being bridged out.
